AVIATION INVESTIGATION REPORT

A03P0136

ENGINE POWER LOSS – HARD LANDING AND ROLLOVER

BELL 206B C-GPOS

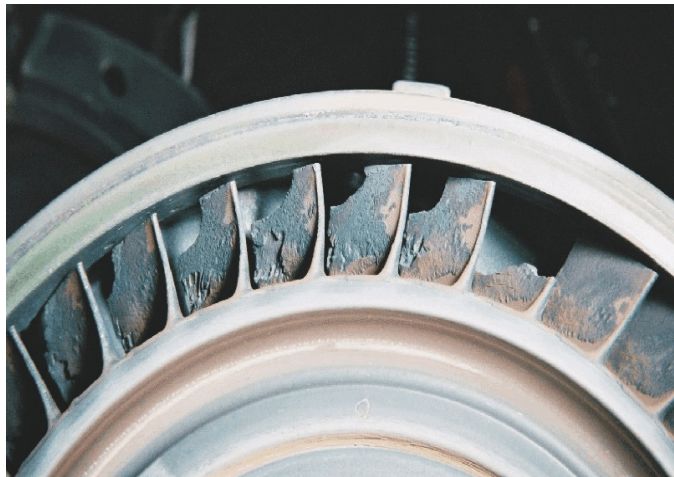
During the examination of the engine, it was installed in an approved engine test facility where a full test was attempted; however, the engine vibrated excessively and the test was aborted. Some smoke was evident during the spool down of the engine. The engine was then disassembled for inspection. Of the 38 blades on the number 1 gas producer (GP) turbine, 29 were damaged significantly. One was broken off close to its root, and most of the others were missing pieces. Examination of the remaining fracture surface of the blade that broke close to its root showed indications of a progressive failure (fatigue crack). The other fracture surfaces showed failure by overload. More detailed examination of the GP turbine blades showed extensive sulfidation corrosion¹ (see Photo 1). The blade surfaces were flaking and there were fatigue cracks in many of the blades. The turbine first-stage nozzle labyrinth seal was damaged and the outer fiberglass packing was partially missing. There was soot at the joint between the turbine nozzle and number 1 GP turbine and thick, black, wet soot around the labyrinth seal and on the turbine coupling.

Photo 1. Sulfidation of number 1 GP turbine

There were no periodic power checks carried out, or required, by the operator to detect a power loss, nor maintenance inspections required by the manufacturer or the operator for sulfidation corrosion. It is suggested that either power checks or maintenance inspections would have led to the discovery of the corroded turbine components. The identified sulfidation weakened the GP turbine blades, fatigue cracks occurred on many of the blades, and one of the blades separated. Parts of other GP turbine blades broke off and engine power was lost.

2. A blade in the number 1 GP turbine failed as a result of fatigue, which resulted from sulfidation corrosion; the engine lost power as a result of the blade failure.
3. The helicopter was operating in a high hover when the engine lost power. The ensuing forced landing was hard, the landing gear broke, and the helicopter rolled over.

On 03 October 2003, the TSB sent a Safety Advisory (A030018) to TC, with copies to Rolls-Royce, Bell Helicopter Textron, and Cariboo Chilcotin Helicopters Ltd., drawing attention to the predominant cause for the engine power loss – sulfidation corrosion. Because periodic inspections are not required, the risk of this corrosion going undetected in other aircraft powered by Rolls-Royce 250 engines remains. The letter stated that TC may wish to consider whether periodic inspections should be carried out to help detect damage caused by sulfidation corrosion.
